# **Debris/Ice/TPS Assessment and Integrated Photographic Analysis of Shuttle mission STS-102**

**DEBRIS/ICE/TPS ASSESSMENT  
AND  
INTEGRATED PHOTOGRAPHIC ANALYSIS  
OF  
SHUTTLE MISSION STS-102**

**March 08, 2000**

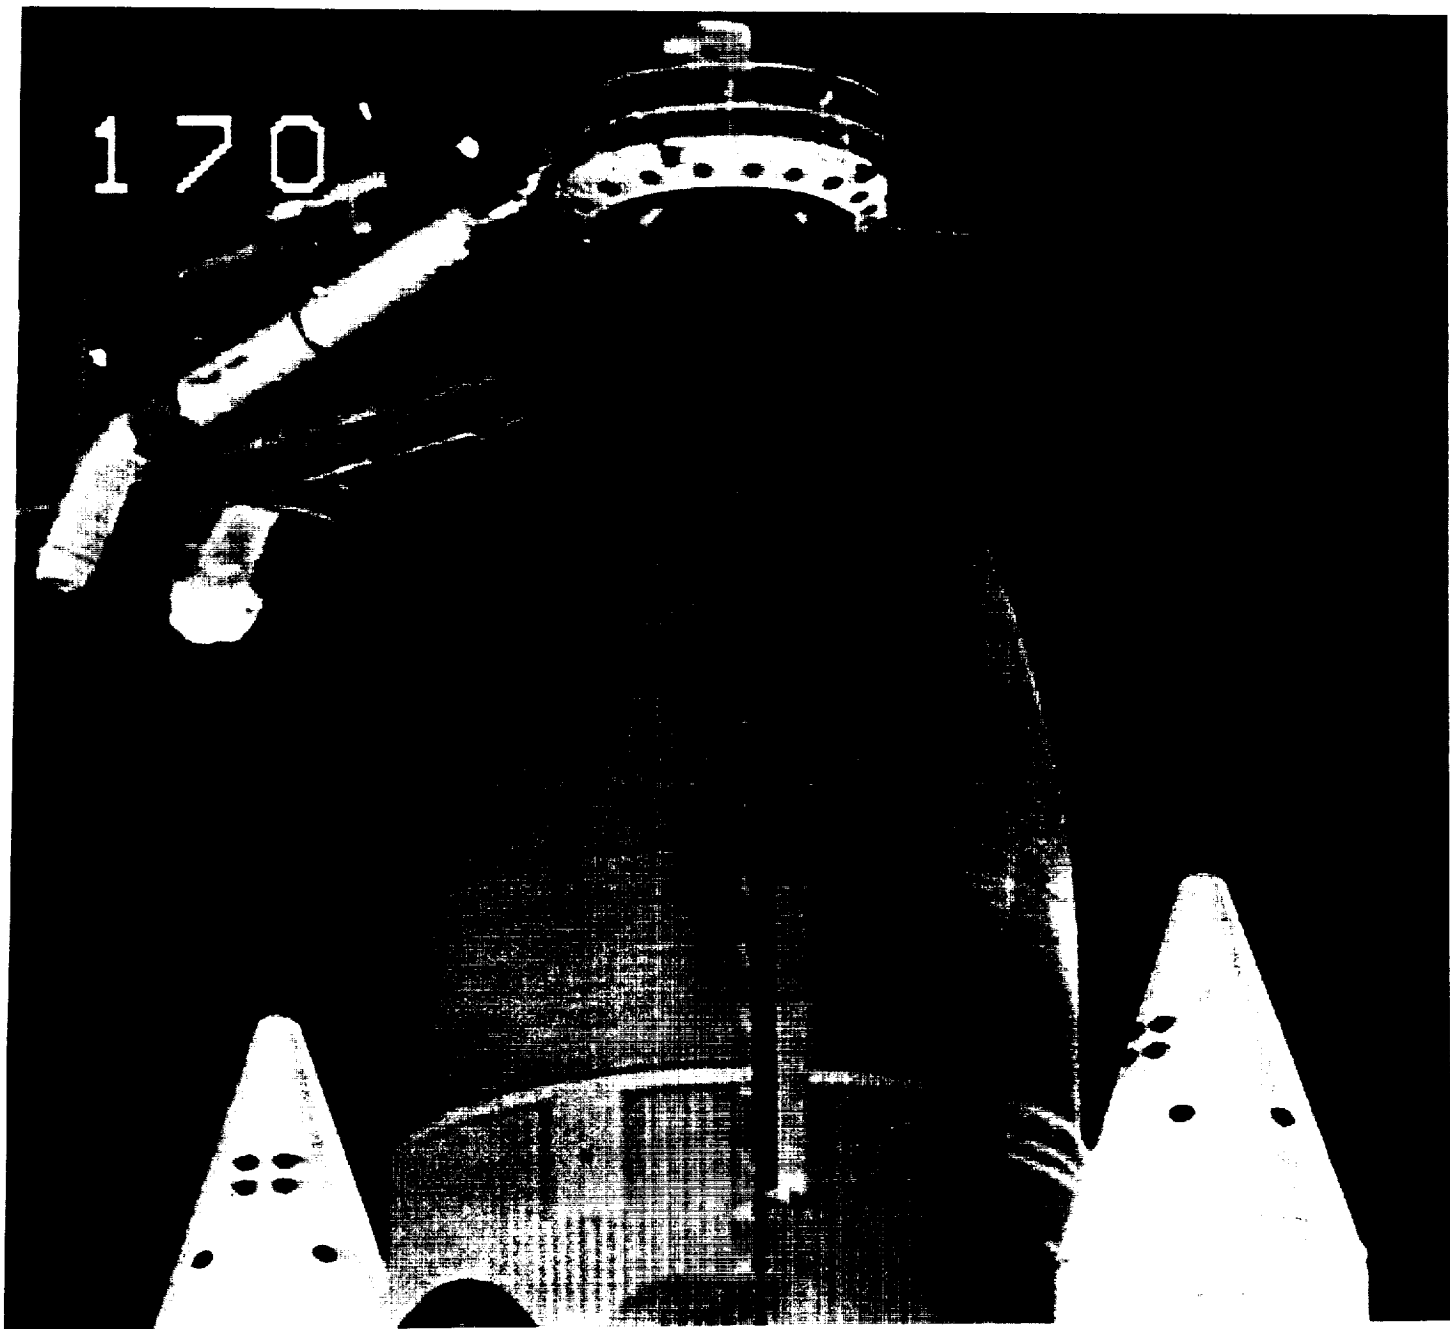
**Photo 4: ET LO2 Tank Forward**

Frost was present on the LO2 tank acreage. Surface temperature ranged from 32 to 41 degrees Fahrenheit. There were no acreage TPS anomalies. This image was captured by OTV camera 170 during the T-20 minutes built-in-hold.

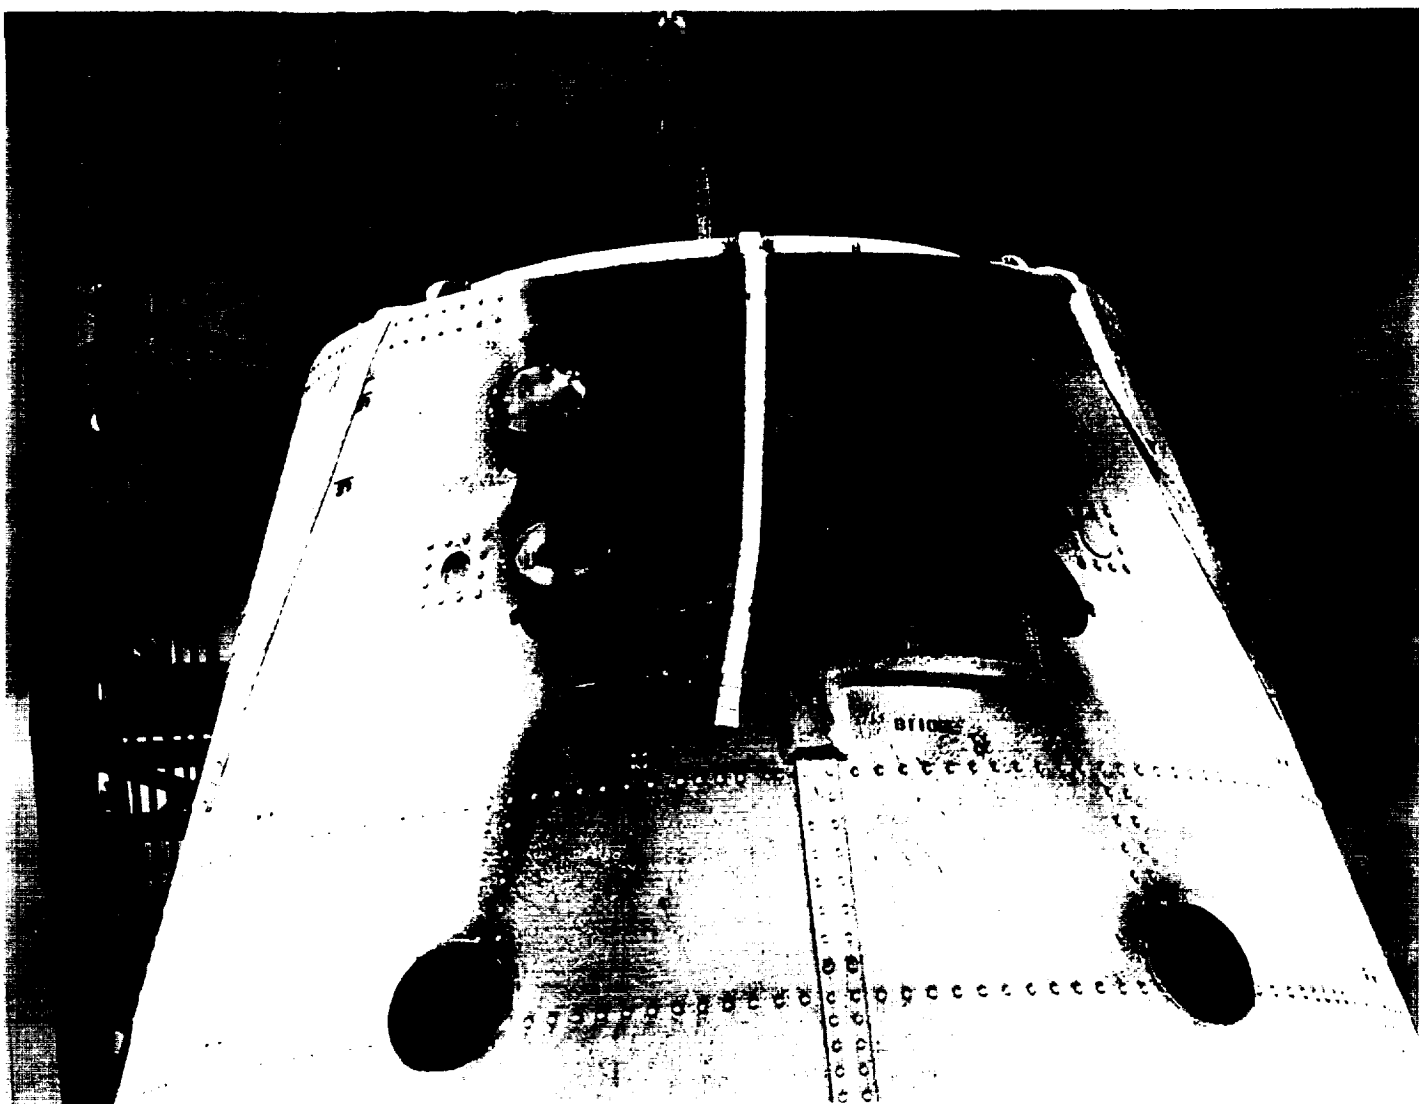
**Photo 12: Frustum Post Flight Condition**

The frustums exhibited no debonds/unbonds or missing TPS.  
All eight BSM aero heat shield covers had locked in the typical opened position.

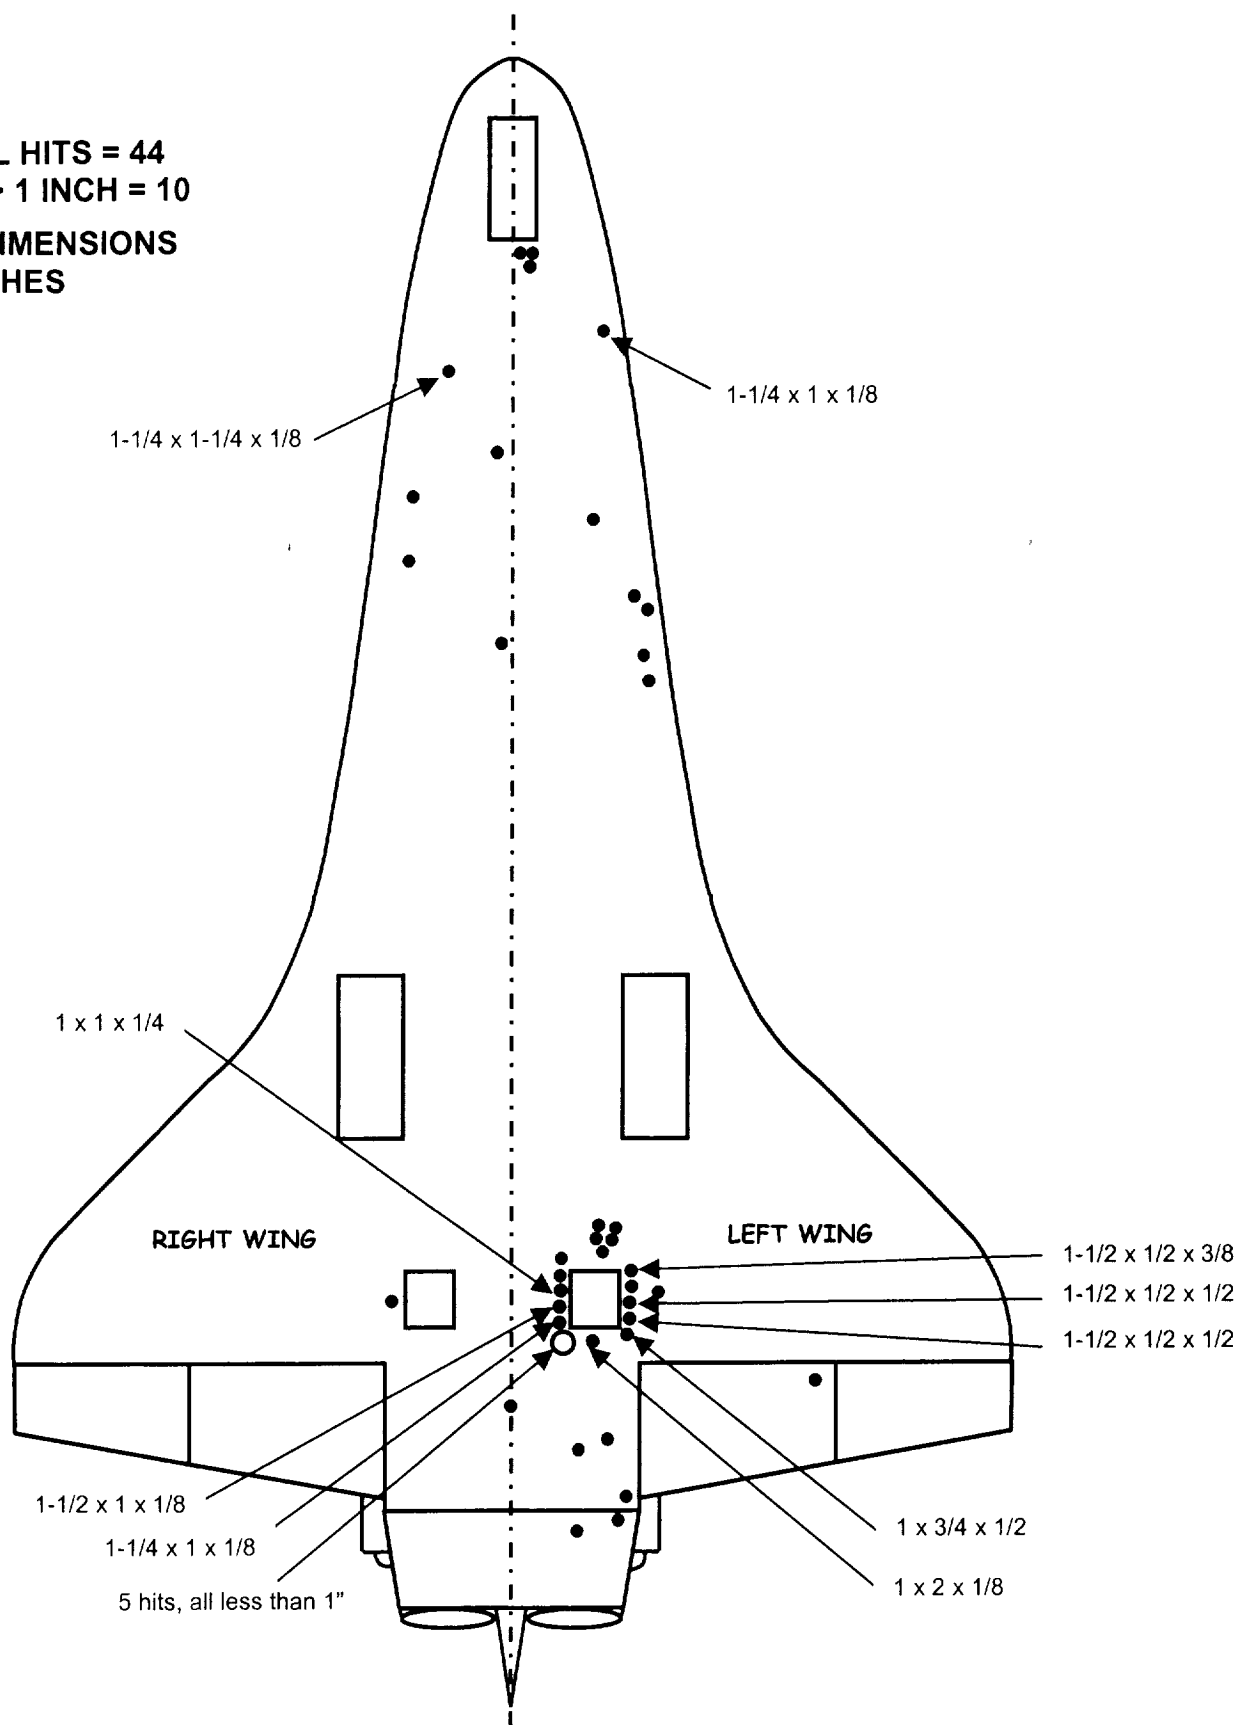
**Figure 1: Orbiter Lower Surface Debris Damage Map**

The Orbiter lower surface sustained 44 total hits, of which 10 had a major dimension of 1-inch or larger, both numbers are well within family. Approximately 14 damage sites (with two larger than 1-inch in length) were located in the area from the nose landing gear to the main landing gear wheel wells. The majority of the hits were around the LH2 umbilical area (22 hits). Most of these damage sites around the ET/ORB umbilical were most likely caused by pieces of the umbilical purge barrier flailing in the airstream and contacting tiles before pulling loose and falling aft. The ET TPS venting modifications continue to have a reducing effect on the quantity and size of the damage sites.

The largest lower surface tile damage site, located inboard of the LH2 umbilical, measured 1-inches long by 2-inches wide by 0.125-inches deep. A combination of umbilical ice and/or umbilical purge barrier material could have been the cause of this damage site.

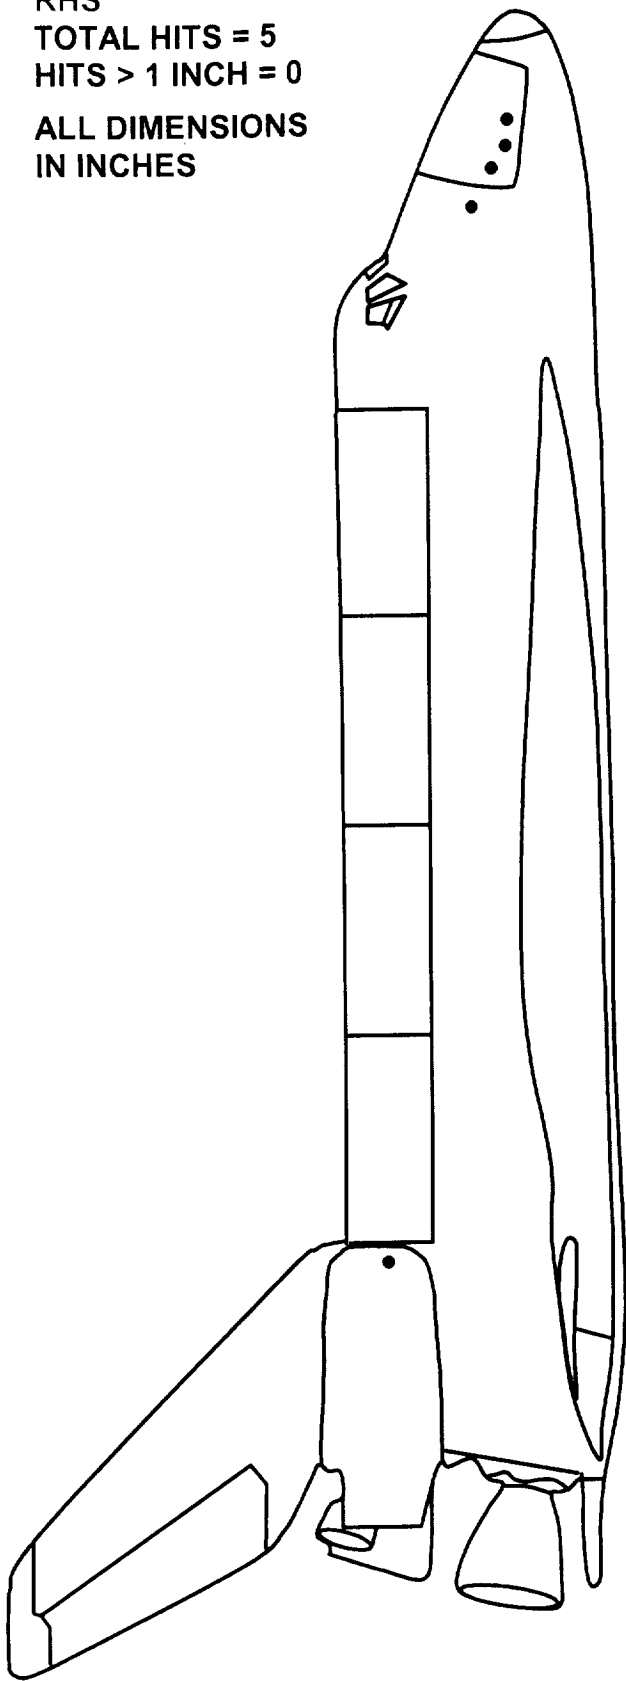
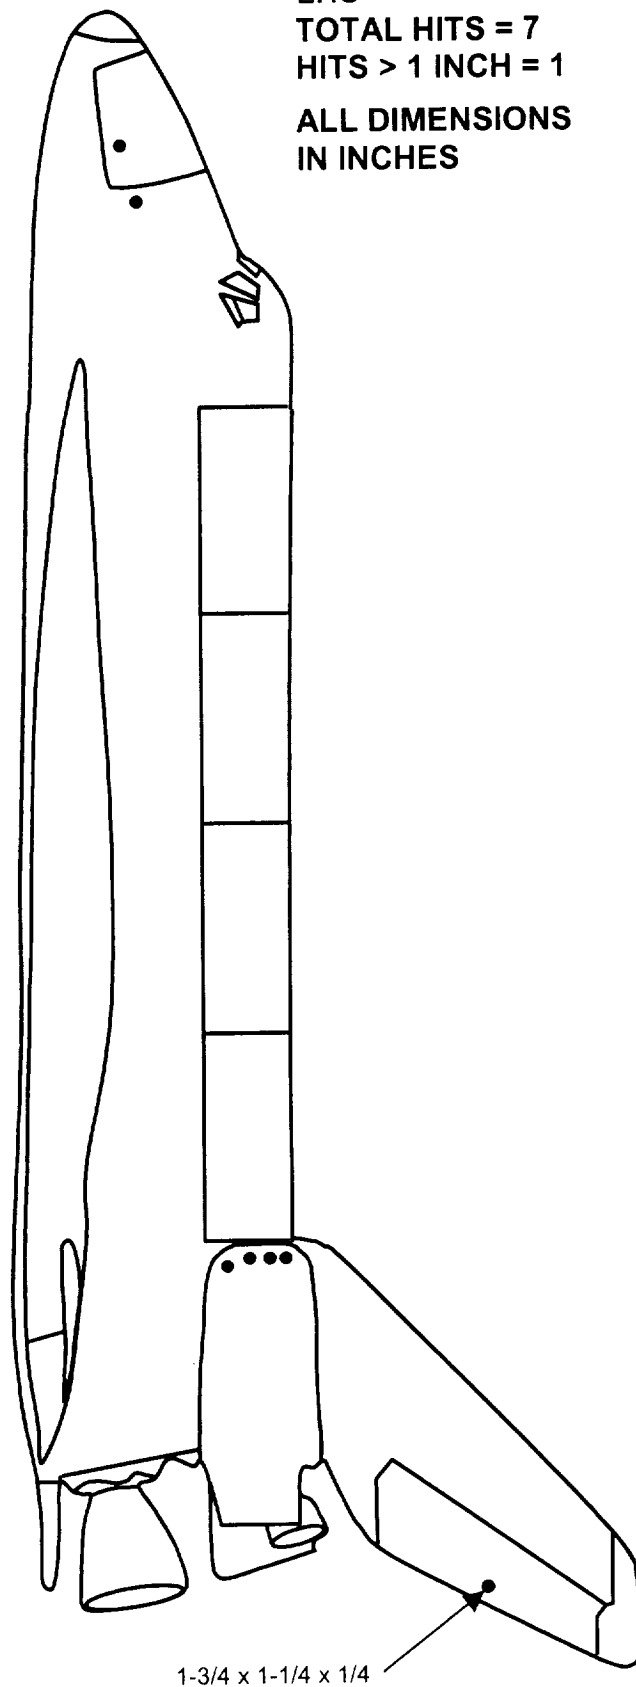
**Figure 3: Orbiter Right/Left Sides Debris Damage Map**

RHS  
 TOTAL HITS = 5  
 HITS > 1 INCH = 0  
 ALL DIMENSIONS  
 IN INCHES

LHS  
 TOTAL HITS = 7  
 HITS > 1 INCH = 1  
 ALL DIMENSIONS  
 IN INCHES

1-3/4 x 1-1/4 x 1/4

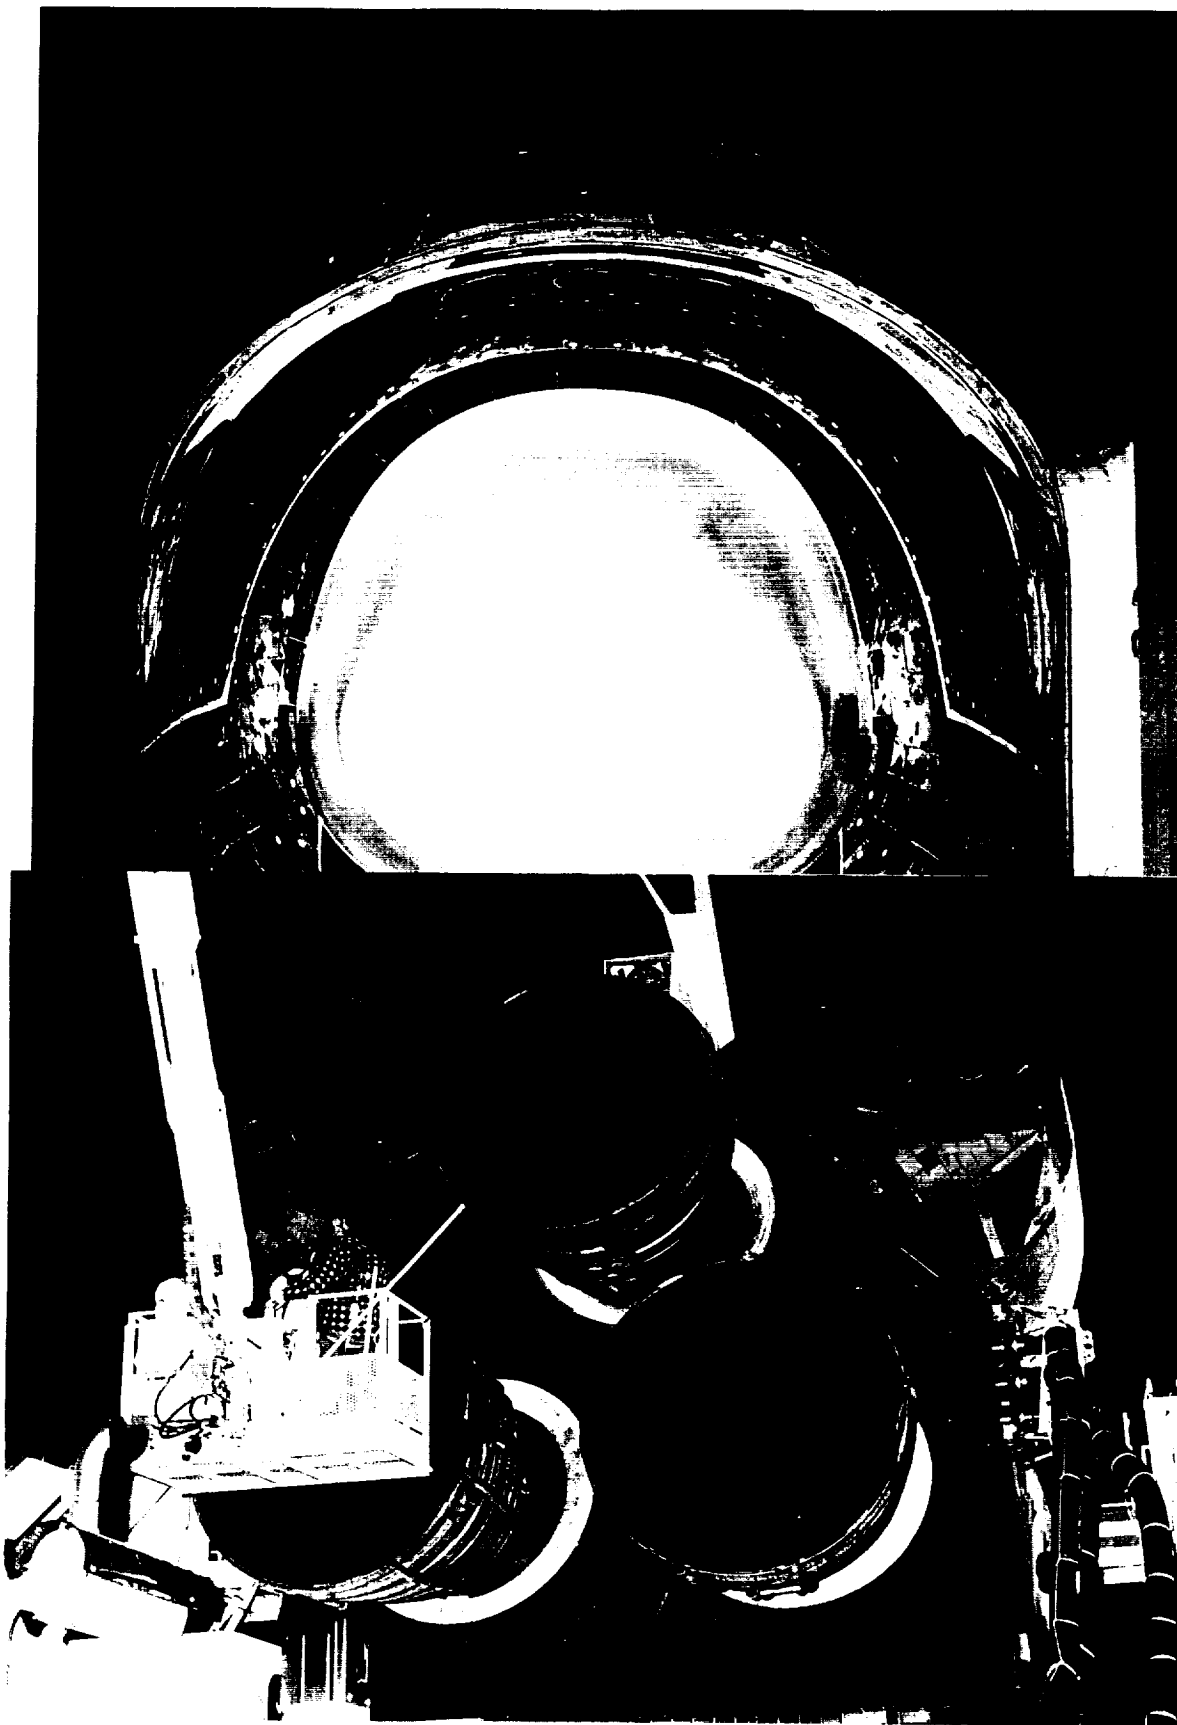
**Photo 17: Windows and Base Heat Shield**

Damage sites on the window perimeter tiles were more than usual in quantity. Less than usual amounts of tile damage occurred on the base heat shield. All SSME Dome Heat Shield closeout blankets were in excellent condition.

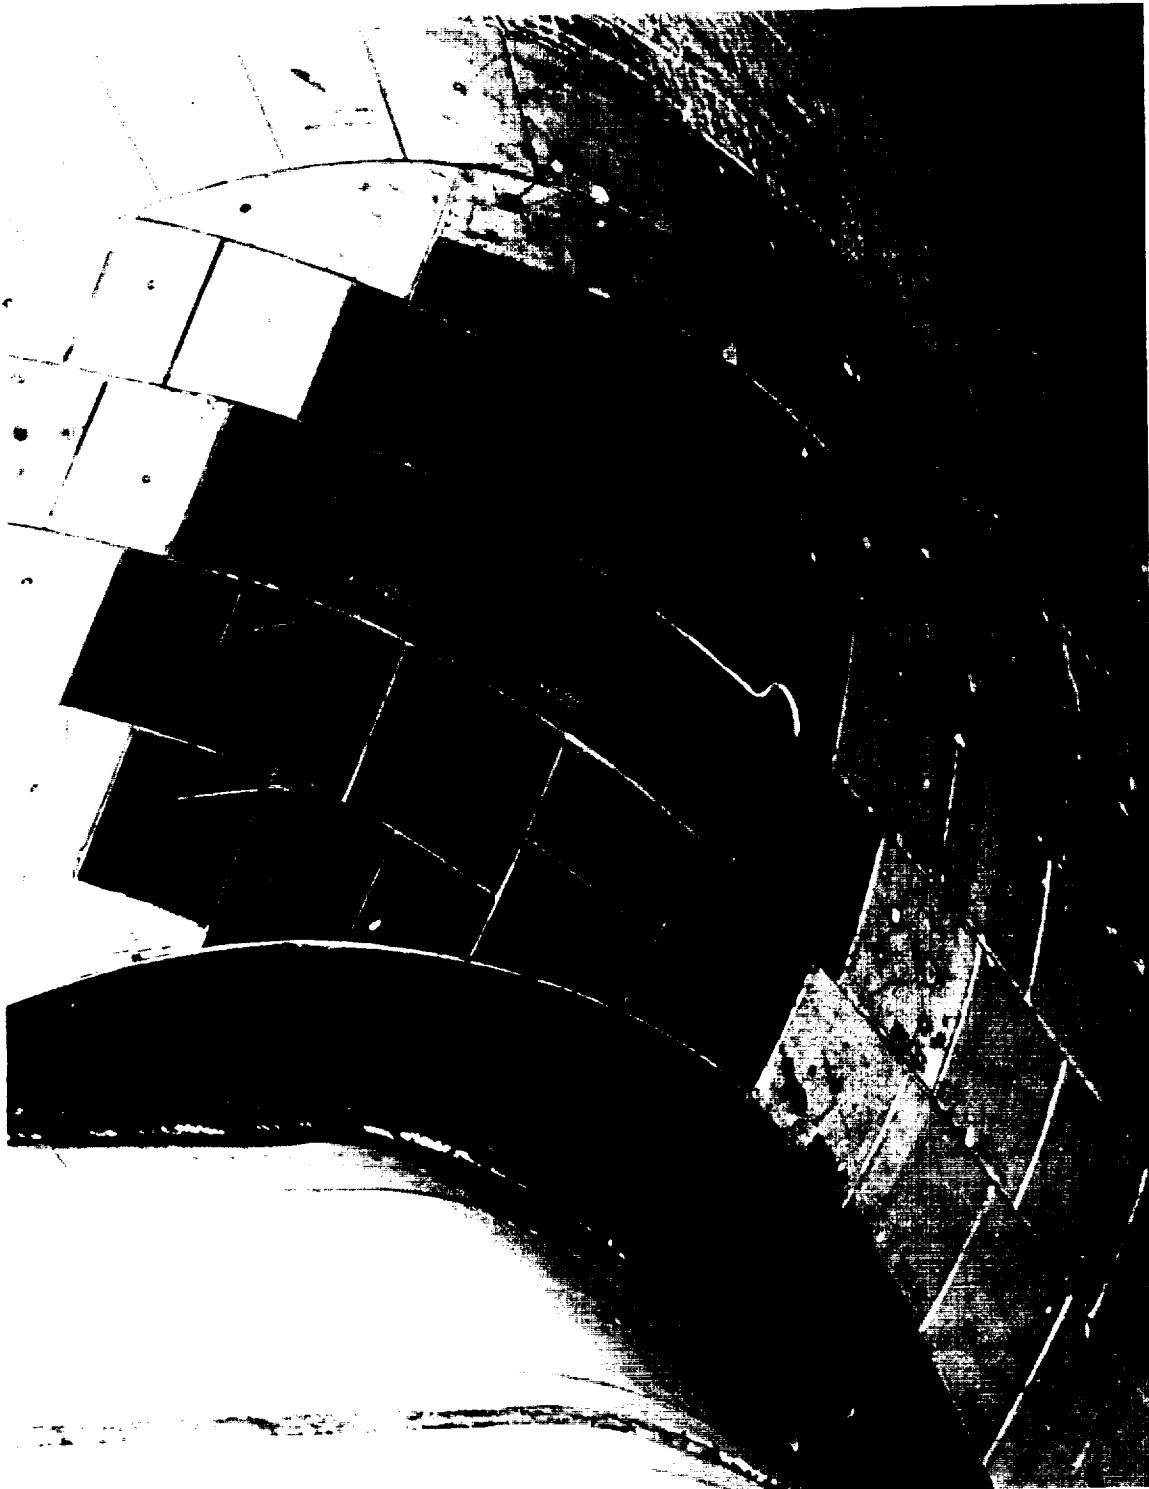
**Photo 19: R/H OMS pod**

One protruding tile gap filler material was found on the R/H OMS pod, approximately 2 inches long.

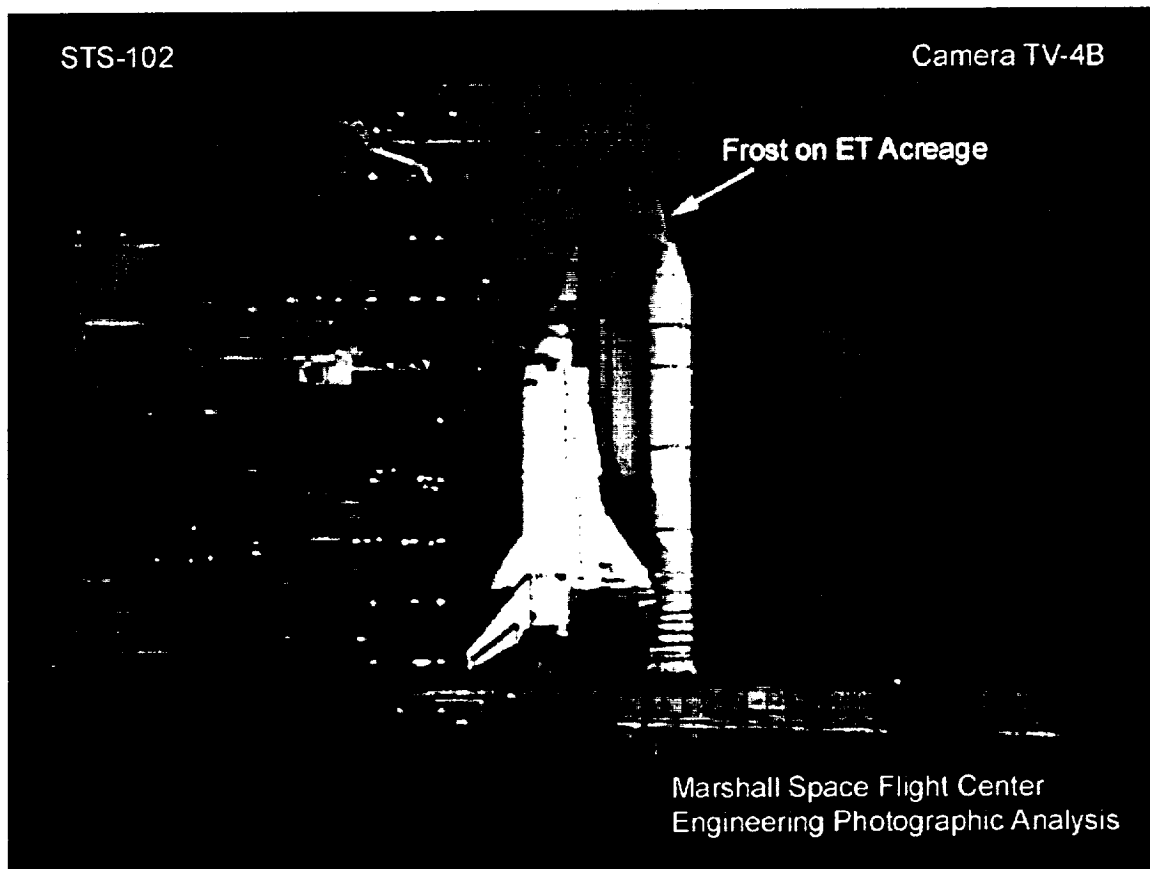
**Figure 1. Frost on ET Acreage**

A large area of the External Tank was coated with frost prior to liftoff. Frost was not observed on later film/video and assumed to have sublimed or evaporated quickly during vehicle ascent.

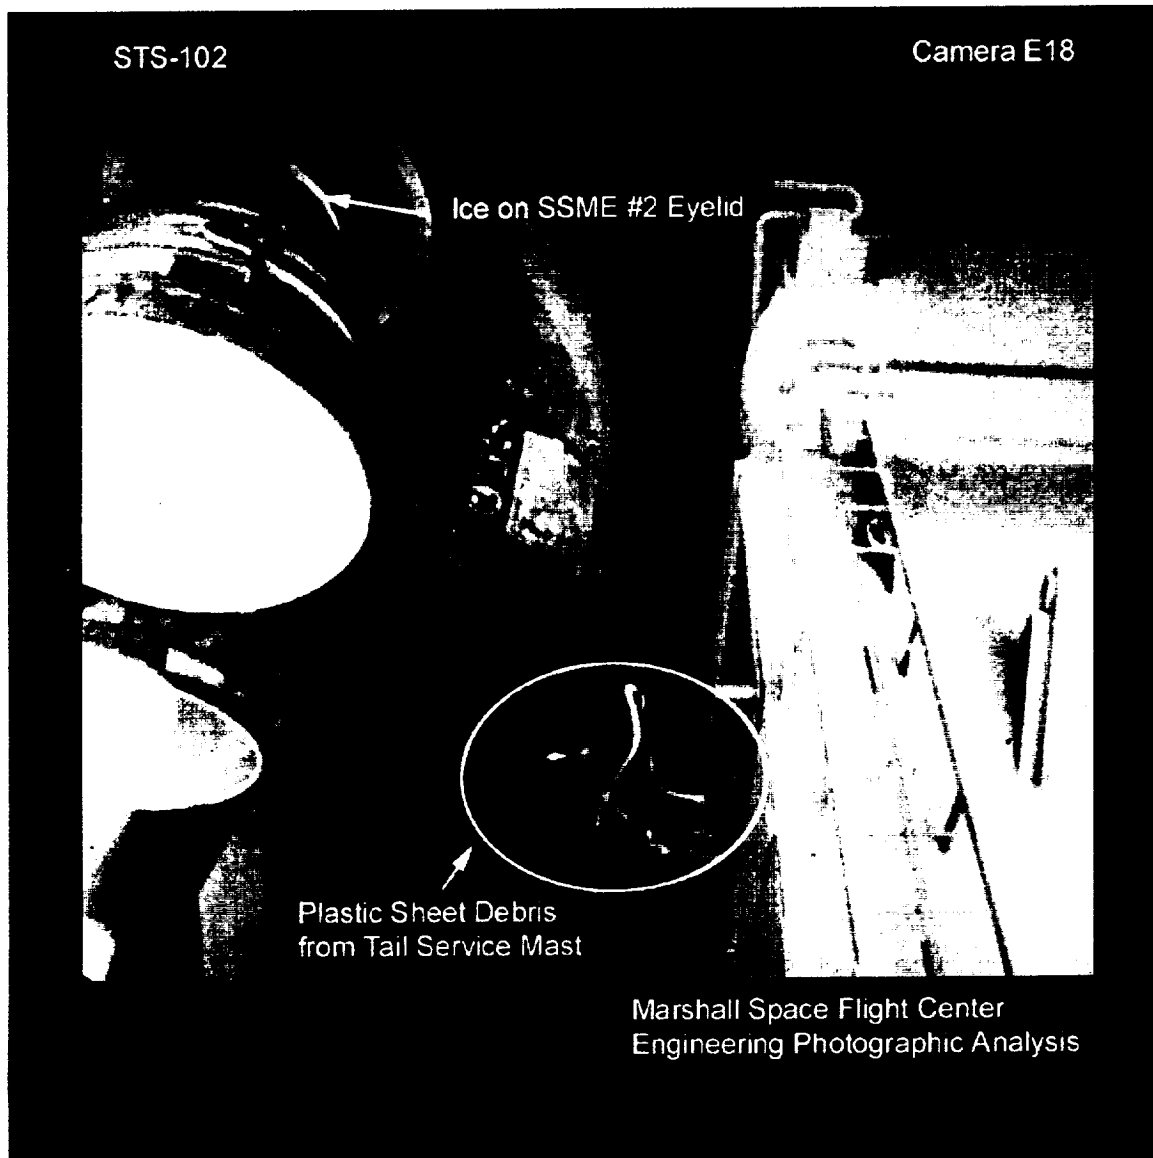
**Figure 10. Debris from the Tail Service Mast**

A sheet of plastic debris, identified as closeout/barrier material from the LH2 TSM Umbilical compartment, fell through the field of view, just after retraction of the LH2 T0 umbilical carrier. Also visible is ice around the SSME#2 eyelid.
